Main Bearing (MnFr): Outer race fault (BPFO)

ET01:FTT_62_Tr - Main bearing

Wind farm	Very Windy	Turbine type	StrongWind 2.5
Location	Turbine ET01	Turbine serial	3018826

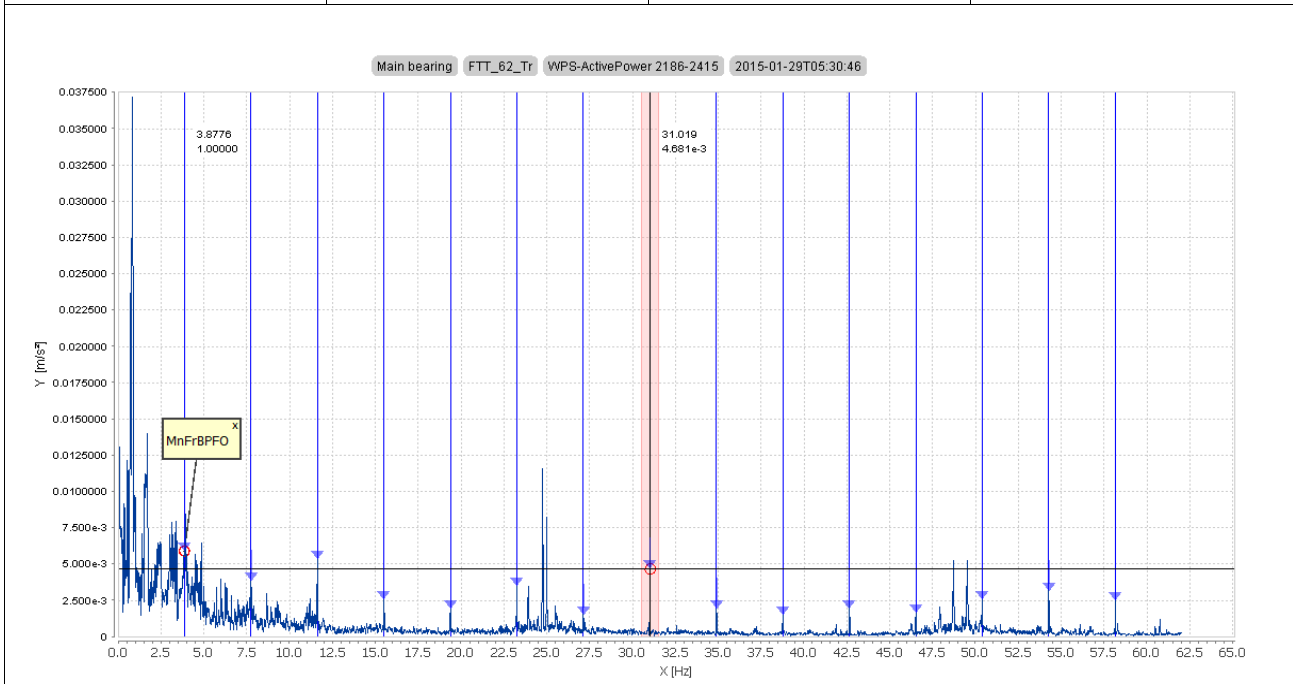
Figure 1

Description	Action	Time for reaction
Clear and severe outer race fault on the main bearing. Trend shows further increase. Exchange of component expected.	Visual inspection of bearing and grease	< 14 days

BPFO with distinctive harmonics.

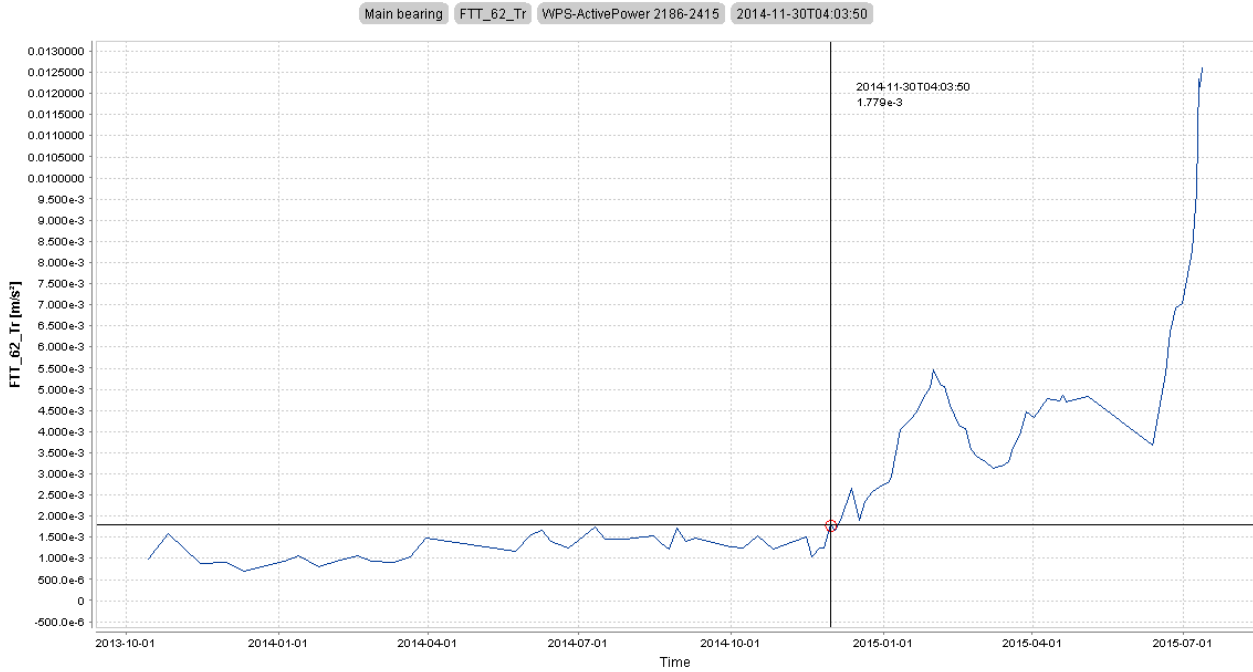
Figure 2

Trend increased since 30/11/2014

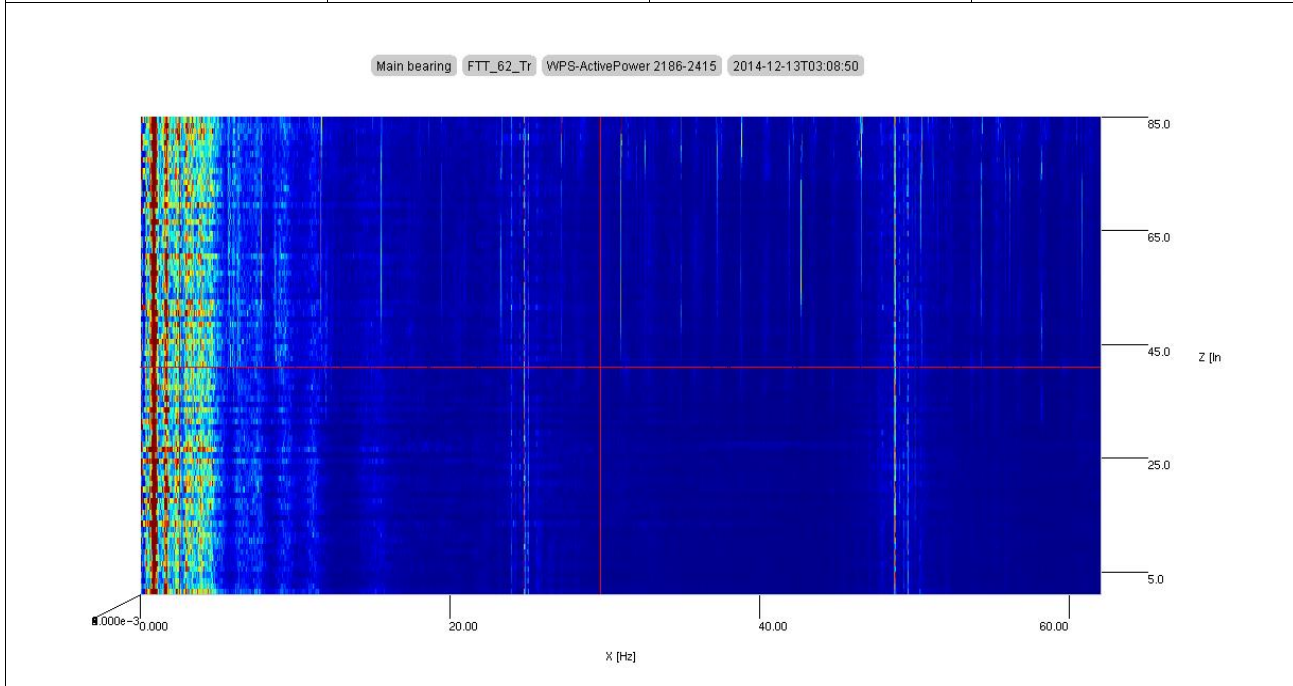
Figure 3

Appearing vertical lines represent increase of BPFO and its harmonics in the whole frequency range.
